DANISH MARITIME AUTHORITY

**MARTIN N / OW COPENHAGEN
Fall overboard on 1 February 2010**

The casualty report has been issued on 3 August 2010.

Case: 201001469

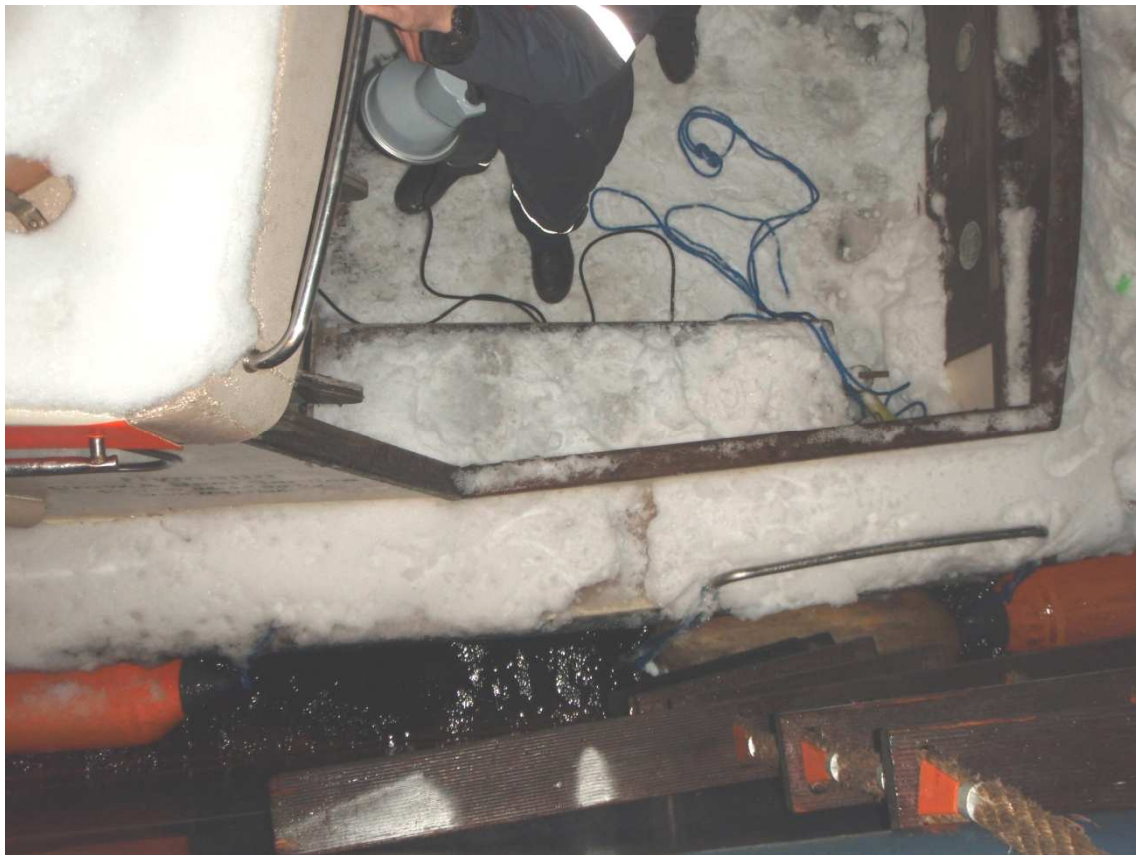
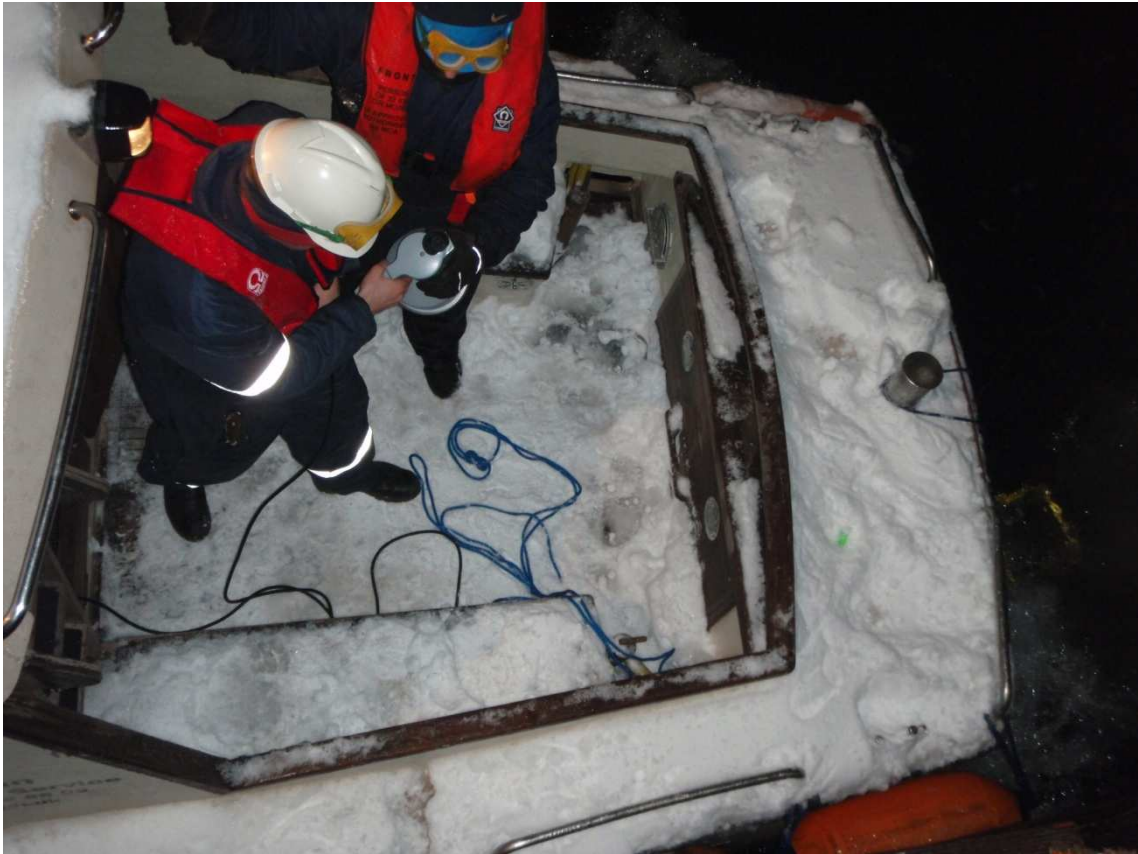
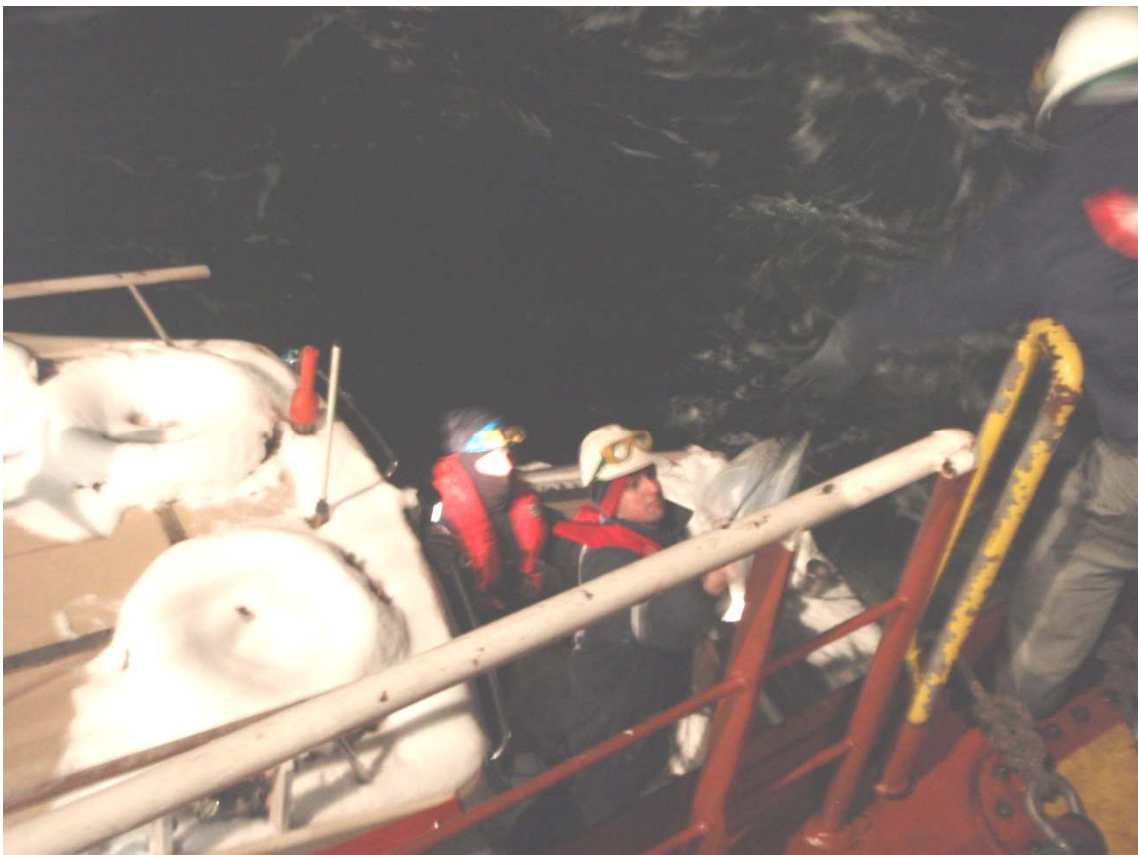
MARTIN N was covered with ice and snow on all outdoor surfaces.

MARTIN N's aft deck viewed from OW COPENHAGEN

All outdoor surfaces on MARTIN N, including the lifebuoys, were covered by ice and snow.

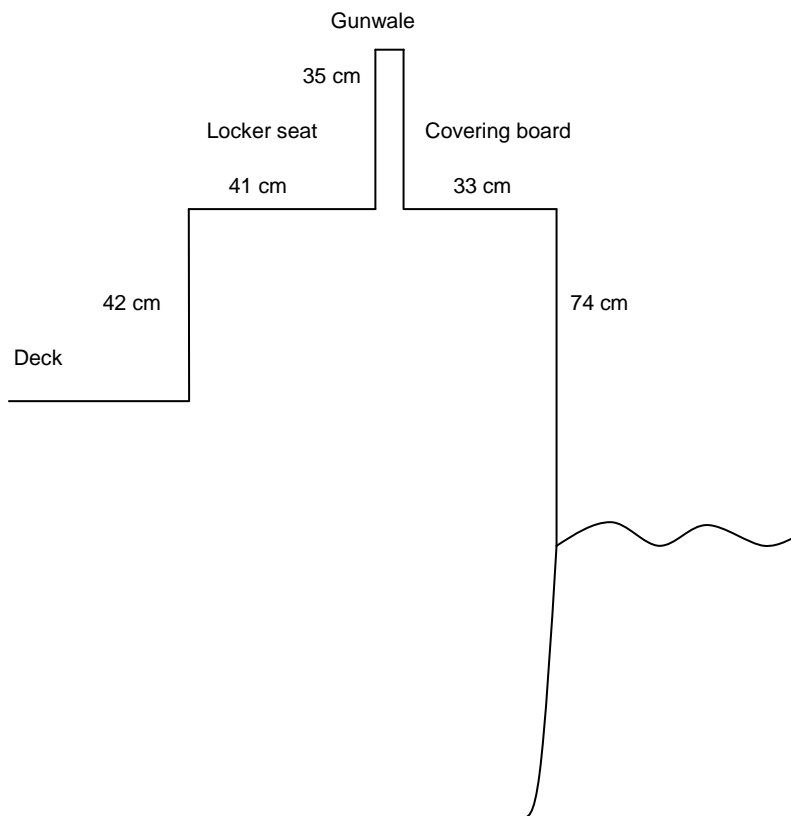
The height of the gunwale on the launch is 77 cm above deck level, and a locker seat and a covering board made it even more difficult to reach a person in the water when leaning over the gunwale (see dimension sketch on the next page).
