Division for Investigation of Maritime Accidents. Danish Maritime Authority,  
Vermundsgade 38 C, DK 2100 Copenhagen  
Phone: +45 39 17 44 00, Fax: +45 39 17 44 16, CVR-no.: 29 83 16 10  
E-Mail: [oke@dma.dk](mailto:oke@dma.dk) – [www.sofartsstyrelsen.dk](http://www.sofartsstyrelsen.dk)

**The casualty report has been issued on 08.06.2010**

**Case:** 201000032

# 1 Summary

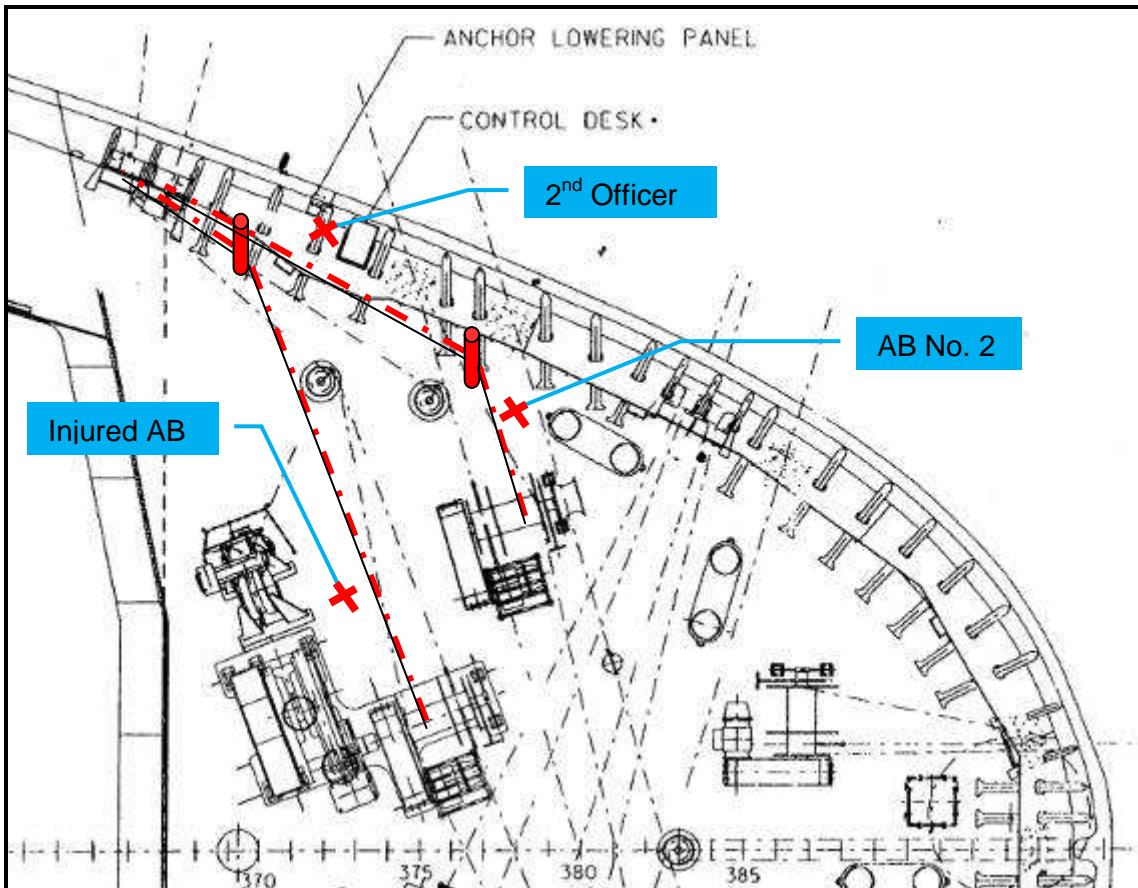
At 1634 both port side spring lines were let go. Whilst the spring lines were being heaved, one AB was controlling and assisting the aft spring line to spool properly on the storage drum. The other AB was controlling and assisting the forward spring line to spool properly on the storage drum. See picture 1.

Picture 1: Accident scene before the accident.

As the spring lines were approaching the adjacent roller fairleads, the messenger lines entangled.

The aft rope guide bended and the aft spring line flipped over the rope guide and snapped back. The AB assisting was positioned aft of this spring line. He was hit by the line and was slung into the windlass foundation.

The forward rope guide broke off and the forward spring line snapped back. The AB assisting was positioned forward of the line. He was not hit.

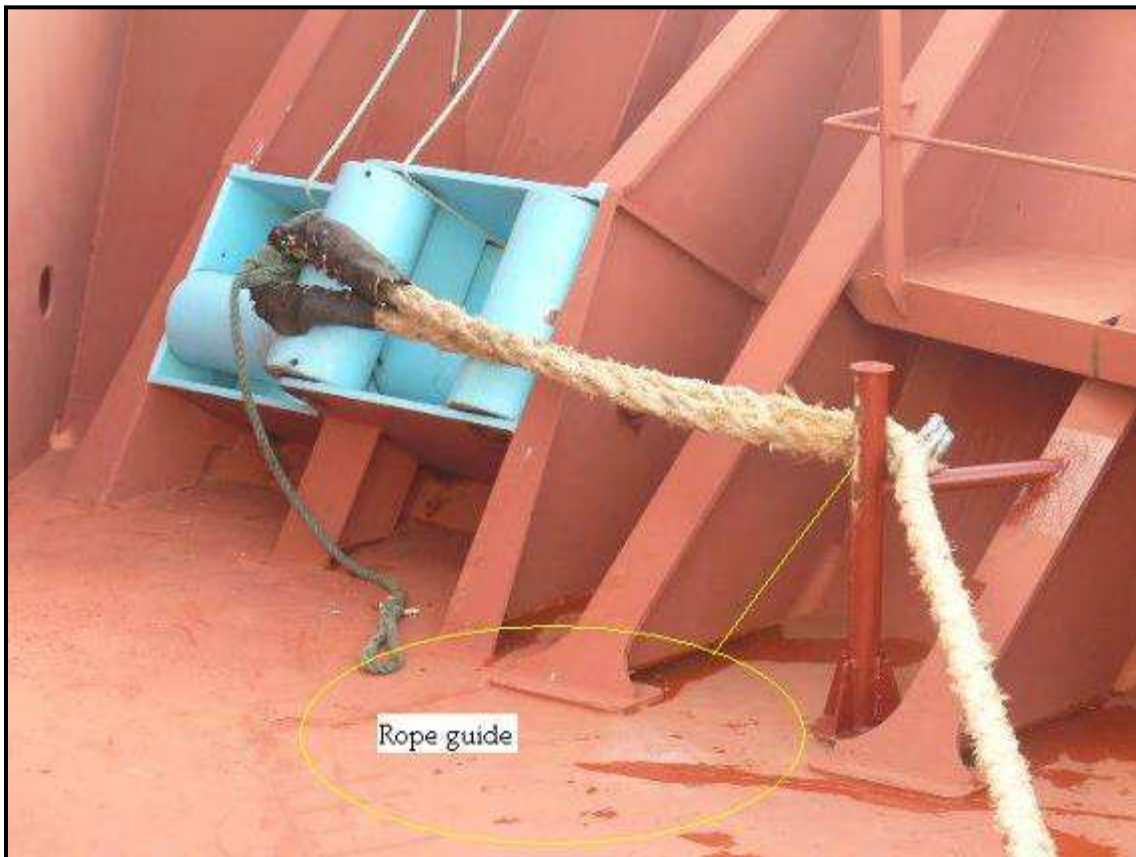
Picture 2: Spring line and rope guide.

Observations had been made previously on board of messenger lines getting entangled and rope guides being bended.

The aft rope guide bended and the aft spring line flipped over the rope guide and snapped back.

The forward rope guide broke off and the forward spring line snapped back.

The rope guides did not have enough strength to absorb the load from the sudden tightening of the spring lines.

- Ensure that safety planning and communication in connection with hazardous routine tasks is maintained at a sustainable level on board.
- Ensure safety assessments of improvement concepts and suggestions as part of the implementation on board.
