**MARINE ACCIDENT REPORT
DIVISION FOR INVESTIGATION OF MARITIME ACCIDENTS**

**KNUD LAURITZEN
Accident to seafarer
4 February 2009**

The casualty report has been issued on 24 April 2009

Case: 200903010

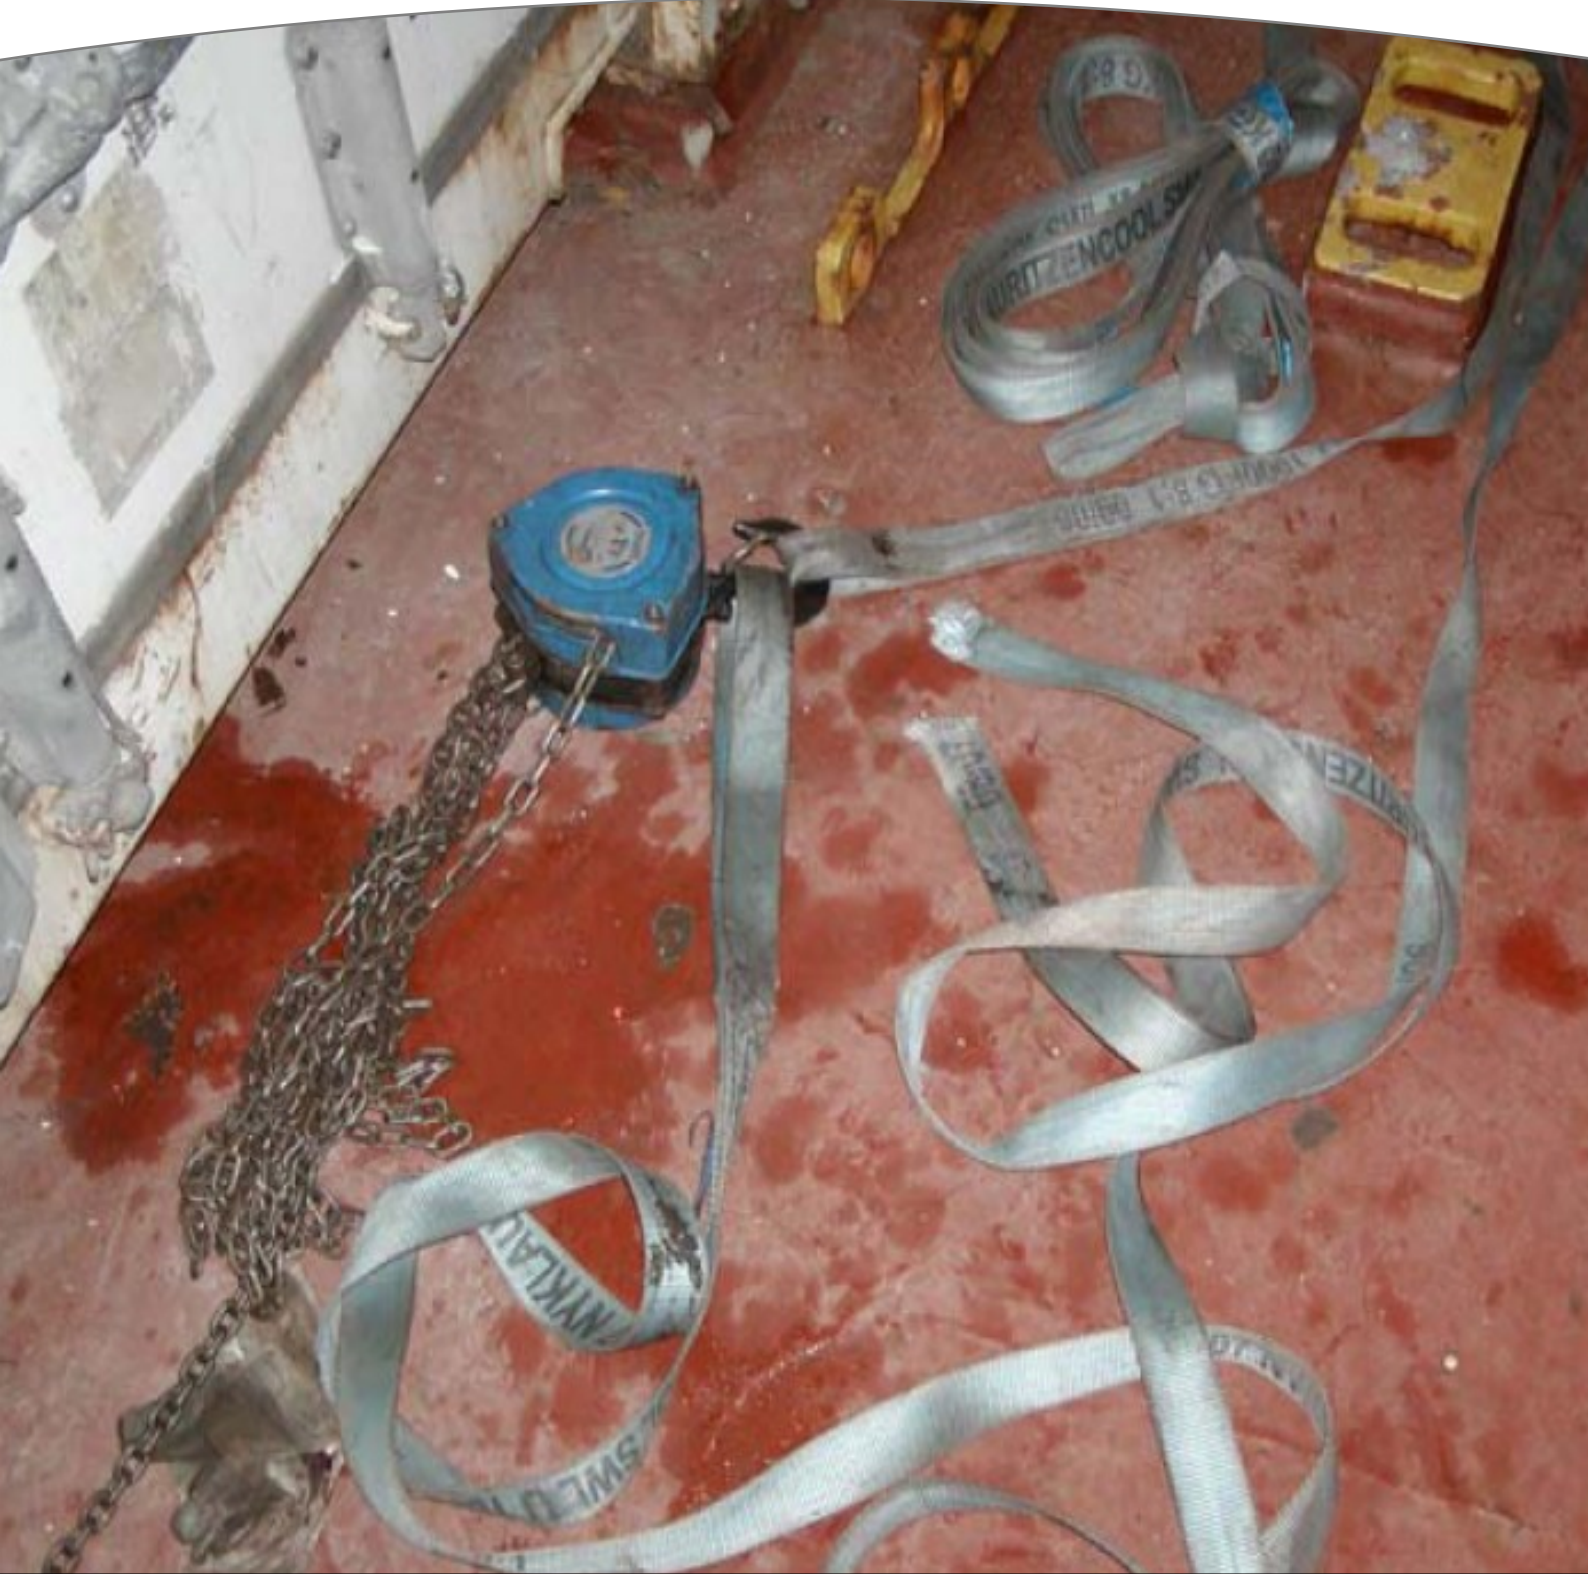
The picture on the front page shows the chain block and the broken sling. (By courtesy of J. Lauritzen.)

The accident was thoroughly discussed. The conclusion of the Safety Committee was that one of the slings used in the arrangement was cut in two pieces on the sharp edge inside the corner fastening point of the container causing the block and hook to fall on the deck.

To avoid accidents like this in the future, all fastening in container corners or similar positions must be done using shackles, wires or chains and in a position direct at the point of making fast. It must be avoided that ropes, slings and wires are passing over edges or around corners where chafing is possible.

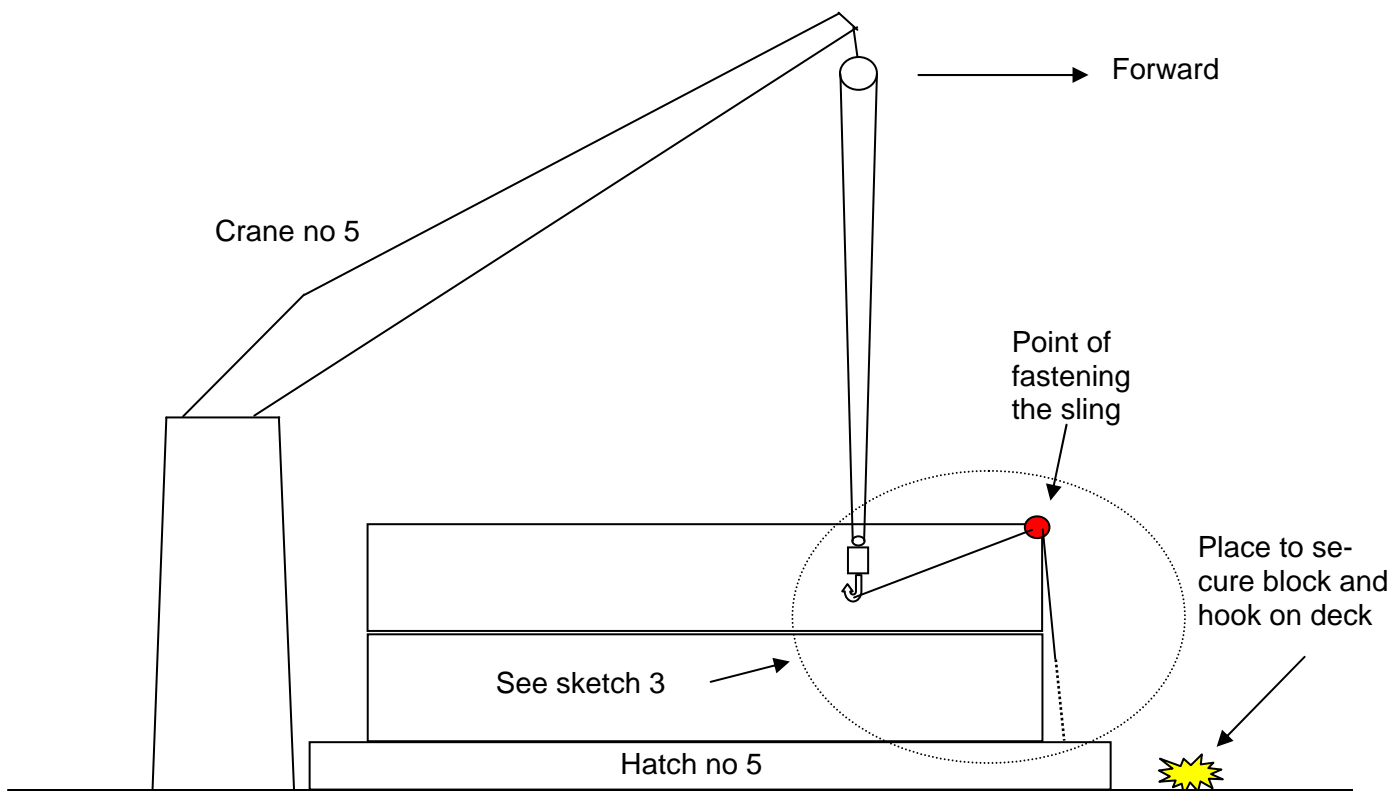
After crane no 5 stopped to work properly, the block and hook was hanging approximately 20 metre below the jib end. To avoid the block and hook from damaging hydraulic cylinders and hoses when landing on the deck between the hatches due to lowering the jib it was planned to fasten the block and hook on the side of the inner row of the containers on the port hatch no 5. The upper container of this row was in tier 2. The block and hook should then be hanging in a suitable distance above the deck enabling the block and hook to be pulled forward to be secured on the deck in front of hatch no 5. This arrangement was discussed between the master, chief engineer and chief officer.

Sketch 1 showing crane no 5 and the inner rows of containers on port hatch no 5.

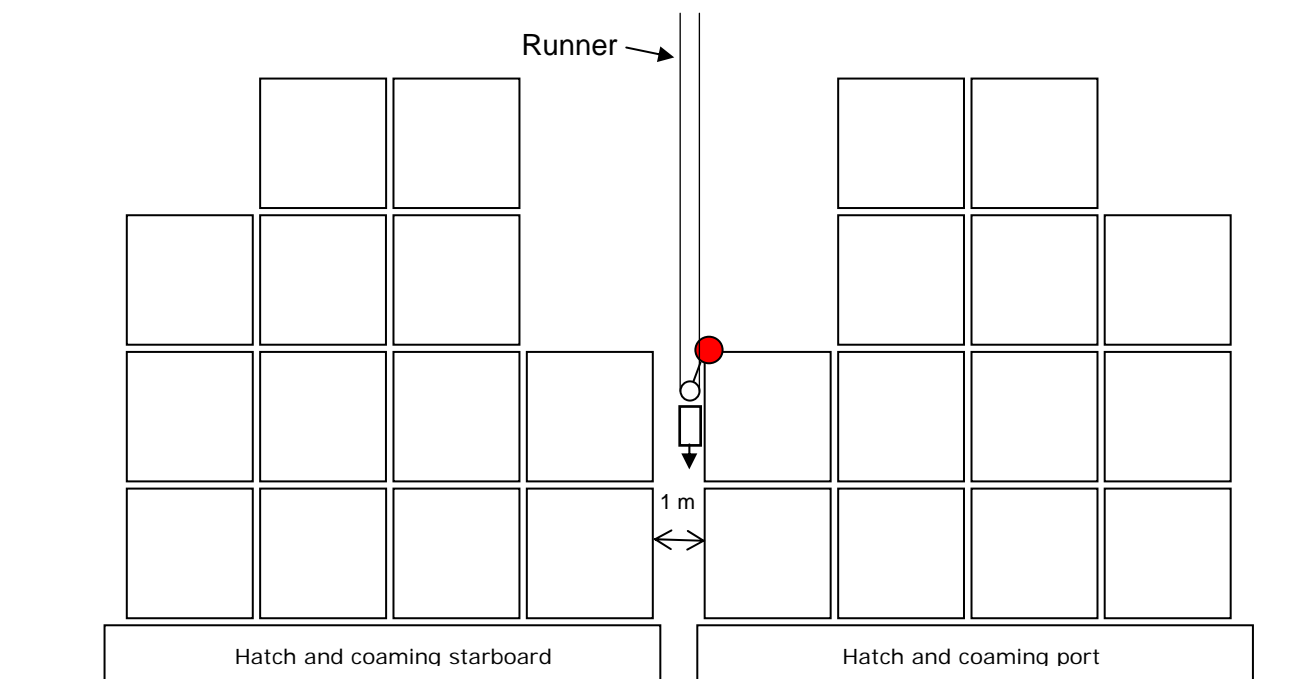
Sketch 2 showing the bay of containers on hatches no 5 seen towards aft

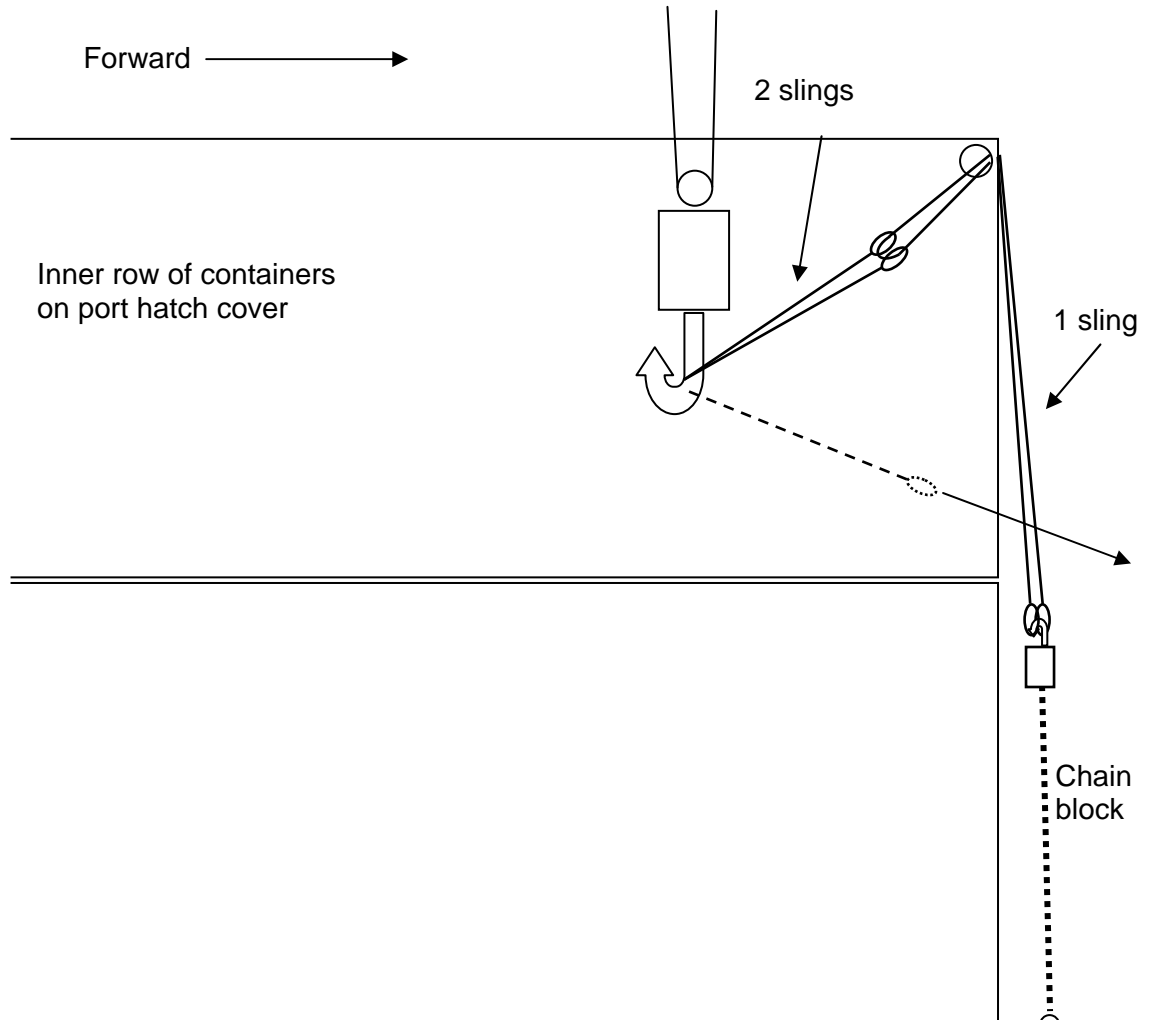
It was agreed to fasten two slings on the cargo hook. A chain block was fastened in the hatch cover just in front of the containers. The chain block was to be used to tighten the slings when lowering the jib. To connect the two slings on the hook with the chain

block, a third sling was used. One of the eyes of this sling was to be placed on the chain block, and then the other eye was to be taken through the container corner used for fastening containers on top. After been taking through the eyes of the two slings on the cargo hook it was finally taken back through the same container corner and placed on the chain block. The plan was to hang the block and hook in the slings when lowering the jib.

Sketch 3 showing the arrangement

There were considerations about the strength of this arrangement. The slings used had a SWL of 1,000 kg and a safety factor of 8. The chain block had a SWL of 1,000 kg. It was considered that this was more than sufficient to handle the total weight of the block and hook which were 460 kg.

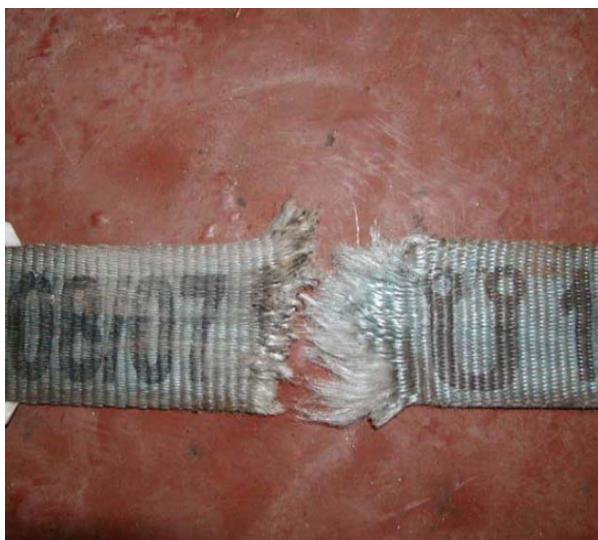
- Due to the defect on crane no 5 a situation in which the crew was inexperienced arose (7.1).
- The solution to secure crane no 5 was thus an operation not tested on prior occasions (7.2).
- The method for solving the problem concerning securing crane no 5 was not thoroughly analyzed for potential element of risks (7.3).
- There was sufficient slack on the runner after lowering the jib to its holder to enable the block and cargo hook to fall to the deck. (7.3).
- The injured person was forced to position himself in a potentially dangerous position due to the arrangement for landing the block and hook on deck. (7.2).
- A sling that was a part of the arrangement was cut in two pieces as it was led over a sharp edge (7.3).

After the accident, the broken sling was sent to an impartial company with regards to the tolerance values of the sling. No qualified reply was received in a reasonable time.

The broken sling

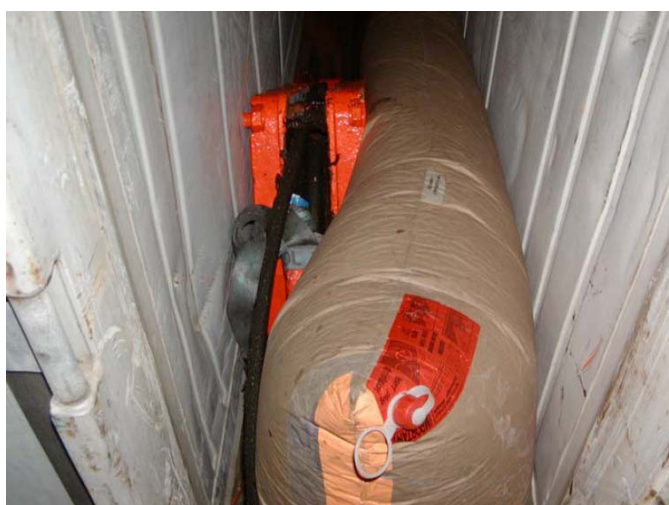
Site of the accident

The chief engineer immediately rushed to the site of the accident and found the chief officer deadlocked between the deck and the starboard containers. The cargo hook and block was lying on top of the chief officers' right leg.

The arrangement called for the chief officer to get very close to the block and hook hanging in the narrow gap between two rows of containers. In the narrow gap there was an imminent danger of getting deadlocked between the containers and the block and hook.

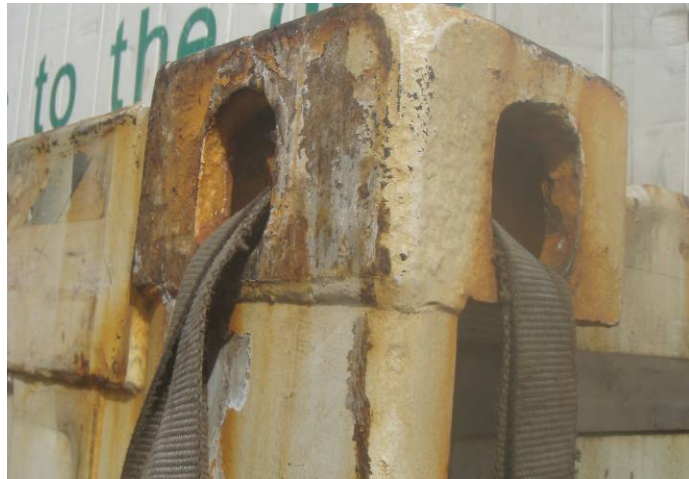
The sling passing over sharp edges J. Lauritzen

The arrangement did not undergo a thorough analysis regarding potentially elements of risk besides the strength of the slings and chain block.

Thus it was not recognized, that the poly propylene sling was resting on a sharp edge in the container corner used for lifting the container and thus in danger of chafing.
