**MARINE ACCIDENT REPORT
DIVISION FOR INVESTIGATION OF MARITIME ACCIDENTS**

**KNUD LAURITZEN
Accident to seafarer
4 February 2009**

The casualty report has been issued on 24 April 2009

Case: 200903010

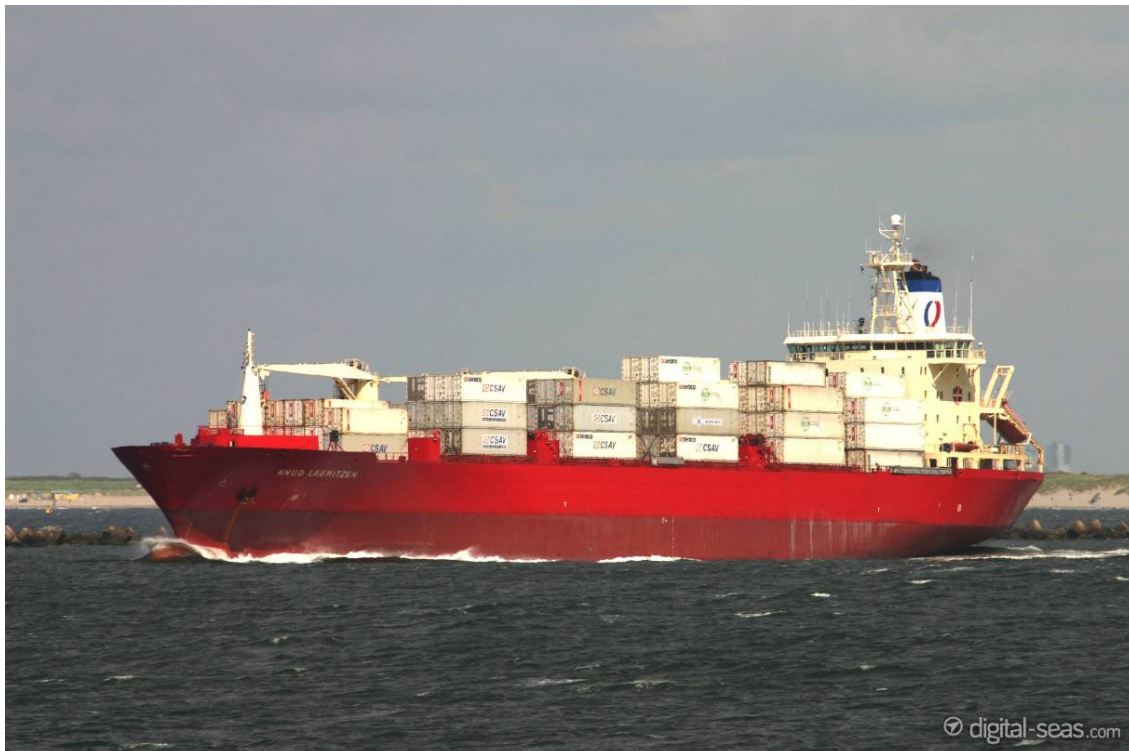
Name	Knud Lauritzen
Home port	Frederikshavn
Call sign	OOUF2
IMO No	8903167
Flag State	Denmark
Construction year	1990
Type of ship	Refrigerated Cargo Ship
Tonnage	14,406 BT
Classification Society	Bureau Veritas

Length	165.00 m
Engine power	12,400 kW
Hull construction	Steel – Double bottom
